# Inventory and Schedule of Condition

## Fixtures & Fittings, Furniture & Effects

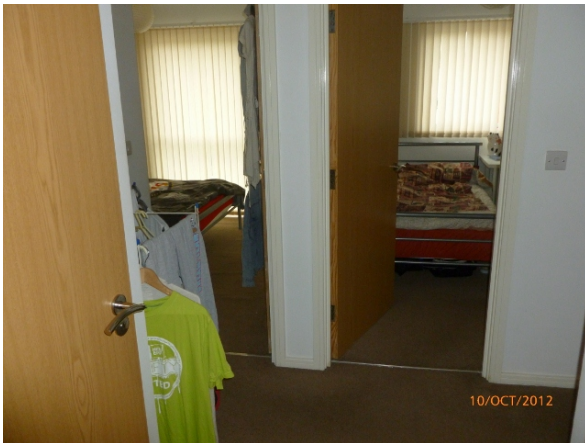
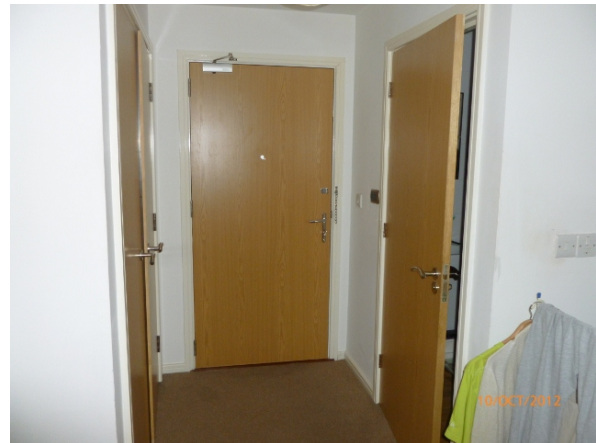
Item	Condition at Check In	Condition at Check Out
Door		
1.	Oak wood style door with chrome effect curved lever handle and lock beneath	
2.	Chrome effect numerals '396' with black frame	
3.	Spy hole	
Reverse Side		
4.	As before with return of handle and twist lock	
5.	Chrome effect automatic door closer	
6.	Return of spy hole with cover	
7.	Bolt	
Door Frame		
8.	White painted	
Door Frame Reverse		
9.	White painted	
10.	Chrome effect chain	
Ceiling		
11.	White painted	
Fixtures		
12.	White circular smoke alarm	Not tested
Walls		
13.	Painted white	
Fixtures		
14.	Chrome effect and black control panel

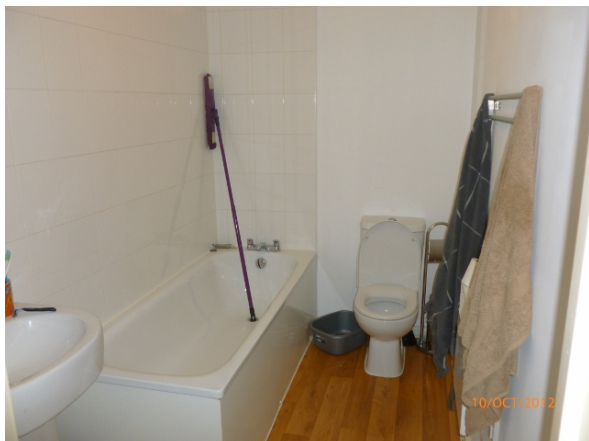
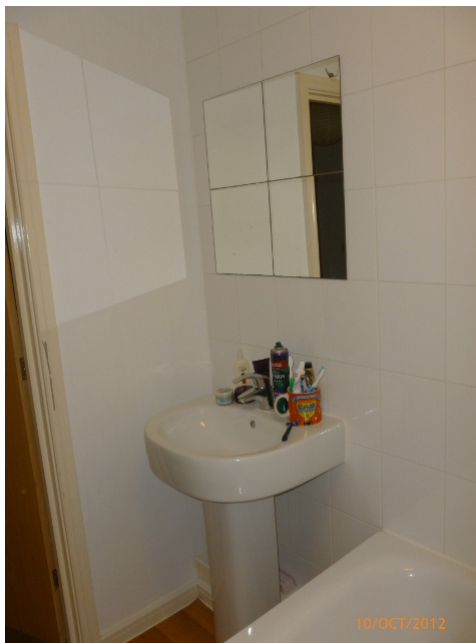
Item	Condition at Check In	Condition at Check Out
Door		
1. Oak wood style door with chrome effect curved lever handle and circular lock		
Reverse Side		
2. As before with return of handle and twist lock		
Door Frame		
3. Painted white	Paint mark on reverse	
Ceiling		
4. White painted		
Fixtures		
5. One Nuaire air vent		
Walls		
6. Part white painted		
7. Part white tiles		
Fixtures		
8. One clothes rail with two bars		
9. One mirror above sink comprising of four mirrored tiles	Some chips to edging	
Floor		
10. Wood style laminate with chrome effect threshold bar

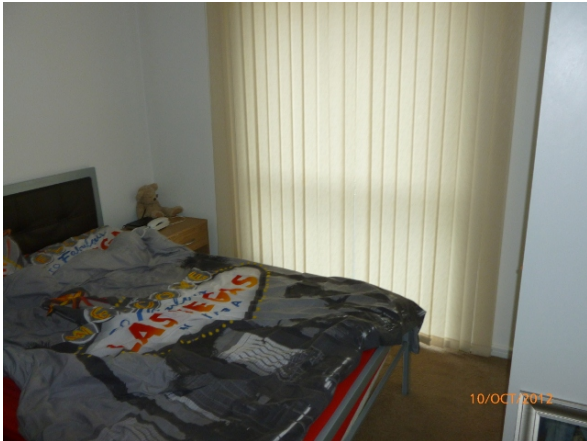
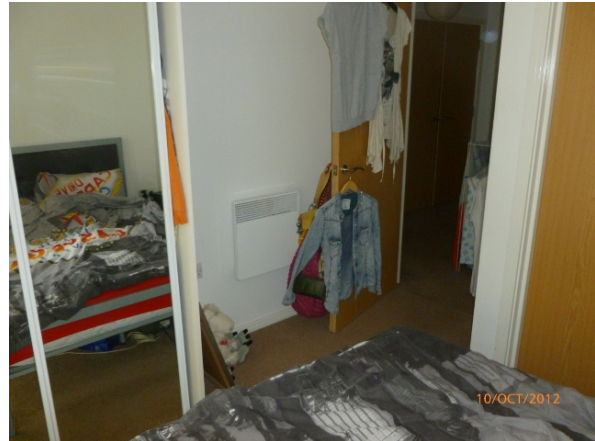
Item	Condition at Check In	Condition at Check Out
Door		
1. Oak wooden style door with chrome effect curved lever handle		
Reverse Side		
2. As before with return of handle		
Door Frame		
3. Painted white		
Door Frame Reverse		
4. Painted white		
Ceiling		
5. Painted white		
Walls		
6. Painted white	Odd scuff marks	
Floor		
7. Beige carpet with metal threshold bar		
Windows and Sills		
Window 1		
8. Double paned white UPVC window with openable top pane and white lever handle		
9. White painted sill	Chips above top panel of window	
Curtains/Blinds		
10. Cream vertical blinds with string and toggle	In working order	
Woodwork		
11. White painted

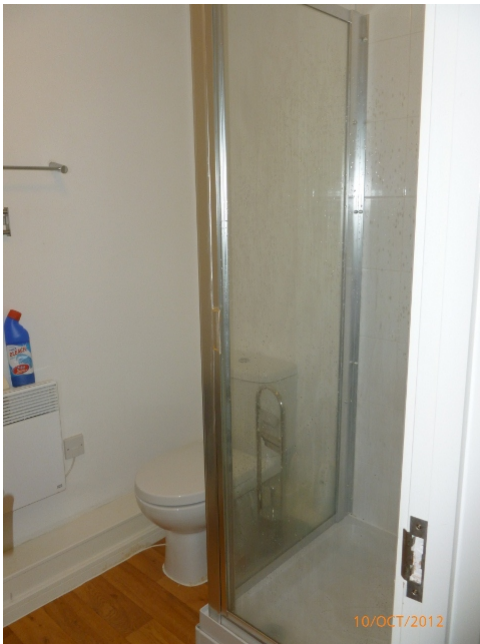
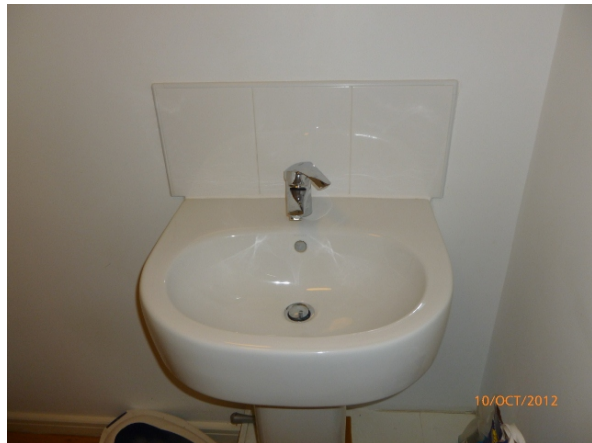
Item	Condition at Check In	Condition at Check Out
Door		
1. Oak wood style with chrome effect curved lever handle and lock		
Reverse Side		
2. As before with return of handle and twist lock		
Door Frame		
3. Painted white		
Door Frame Reverse		
4. Painted white		
Ceiling		
5. Painted white		
Fixtures		
6. One Nuaire air vent		
Walls		
7. Part painted white	Some scuff marks to low levels	
8. Part white tiles in shower area and above sink		
Fixtures		
9. One white shelf		
10. One mirror above sink made up of four mirrored tiles	Lower tiles have plastic hooks attached

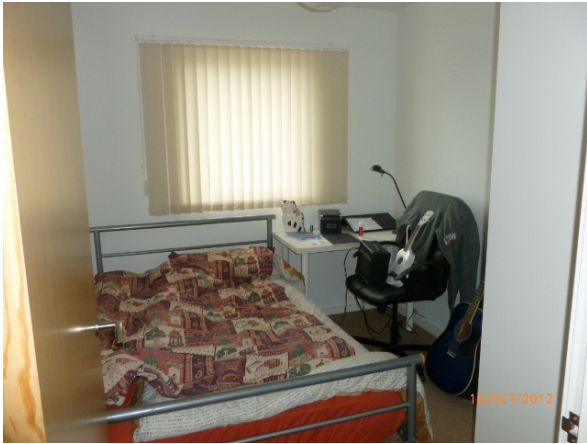
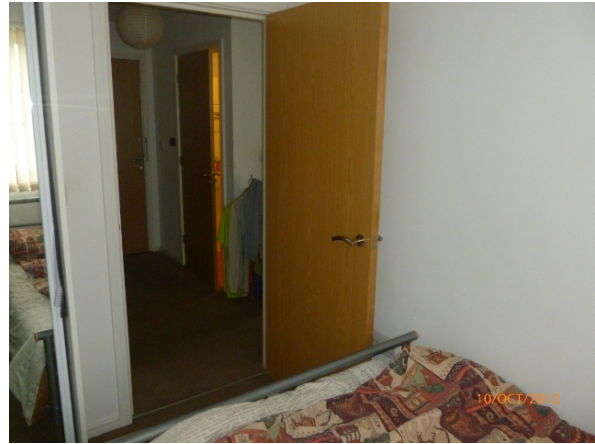
Item	Condition at Check In	Condition at Check Out
Door		
1. Oak wood style door with chrome effect lever handle		
Reverse Side		
2. As before with return of handle		
Door Frame		
3. Painted white		
Door Frame Reverse		
4. Painted white		
Ceiling		
5. Painted white	Small hair line crack to right hand side	
Walls		
6. Painted white	Hair line cracks to far right hand side corner. Scuff marks to low levels.	
Floor		
7. Beige carpet with metal threshold bar	Small black stain marks to right of bed	
Windows and Sills		
Window 1		
8. One white UPVC window with one pane and matching lever handle		
9. White painted sill		
Curtains/Blinds		
10. Cream vertical blinds with string and toggle		
Woodwork		
11. Painted white

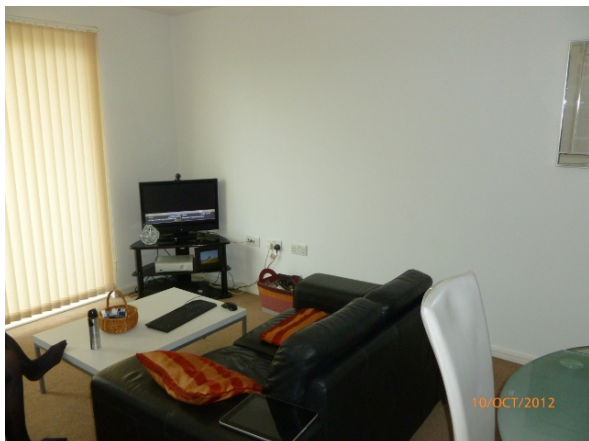
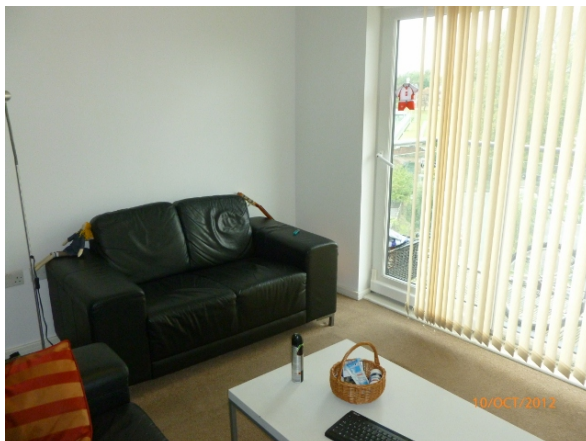
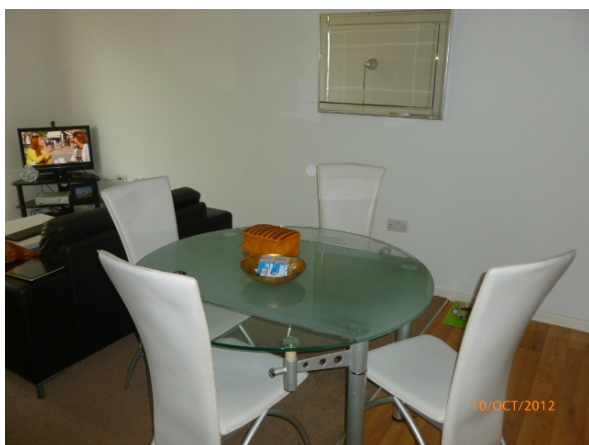
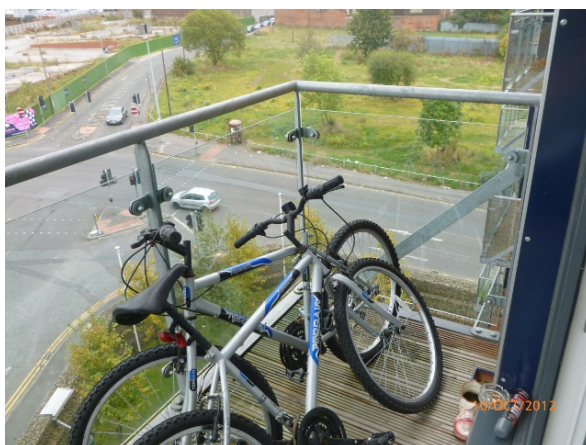
Item		Condition at Check In	Condition at Check Out
Door			
1.	Oak wood style with curved chrome effect lever handle	Some chipping to top edge	
Reverse Side			
2.	As before with return of handle		
Door Frame			
3.	Painted white		
Door Frame Reverse			
4.	Painted white		
Ceiling			
5.	Painted white		
Walls			
6.	Painted white		
Floor			
7.	Beige carpet with metal threshold bar	One tear upon entry. Rising in places to centre.

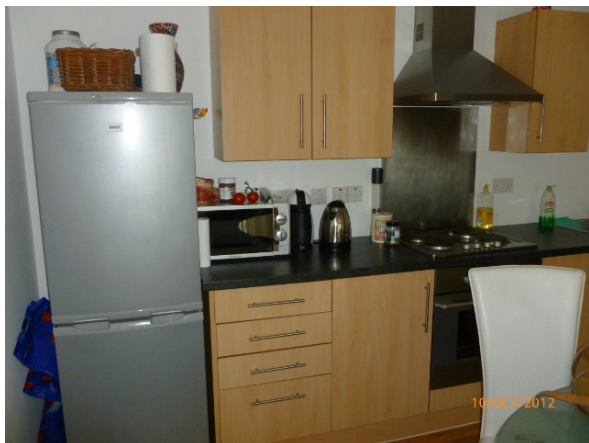
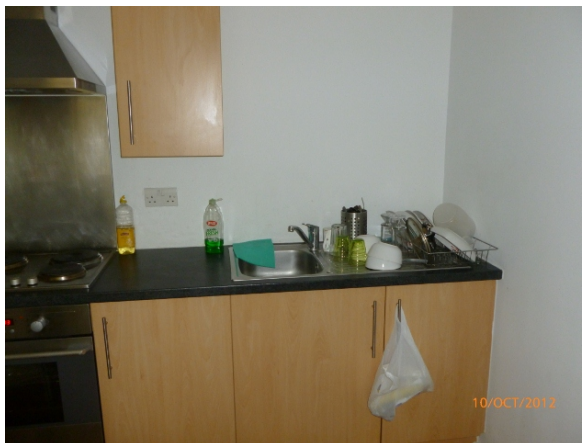
Item	Condition at Check In	Condition at Check Out
Ceiling		
1. Painted white		
Fixtures		
2. One white circular smoke alarm	Not tested	
3. One square Nuaire air vent		
Walls		
4. Painted white	Splash and scuff marks to far wall	
Floor		
5. Wood laminate with metal threshold bar		
Woodwork		
6. Painted white		
7. One door stopper behind door		
Fixed Lighting		
8. One ceiling light on brushed metal effect triangular plate with matching waved rod coming off with four spotlights	All working	
Sockets/Switches/Fans/Cables		
9. White plastic		
Fitted Units/Cupboards		
10. Cupboards: Wood style laminate with chrome effect pencil handles		
Floor cupboards (left to right)		
11. Four drawers with grey lining		
12. One cupboard with one shelf		
13. One cupboard with one shelf

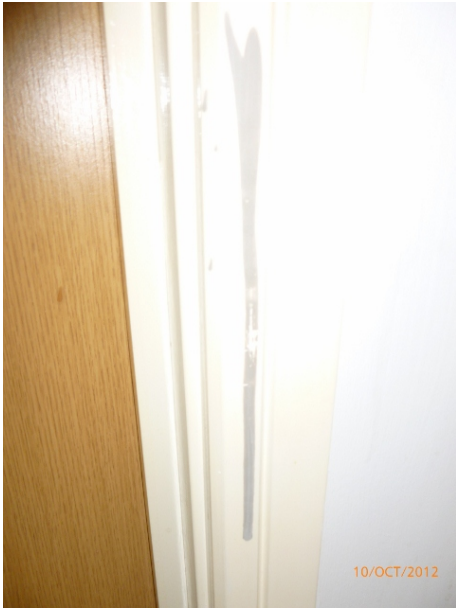
A close-up photograph of a white door frame. There is a vertical line of white paint or plaster on the frame, which appears to be a repair or a mark. A date stamp '10/OCT/2012' is visible in the bottom right corner of the photo.	Information only
En-suite	Laminate flooring coming away around shower	  A photograph showing the corner of a shower area. The laminate flooring is peeling and coming away from the wall and shower pan. A date stamp '10/OCT/2012' is visible in the bottom right corner of the photo.	Information only
En-suite	Yellow marks on shower door handle		Fair Wear and Tear
